Marine Hazards in the Vicinity of Richmond YC

Update on local marine hazards 29MAY2025

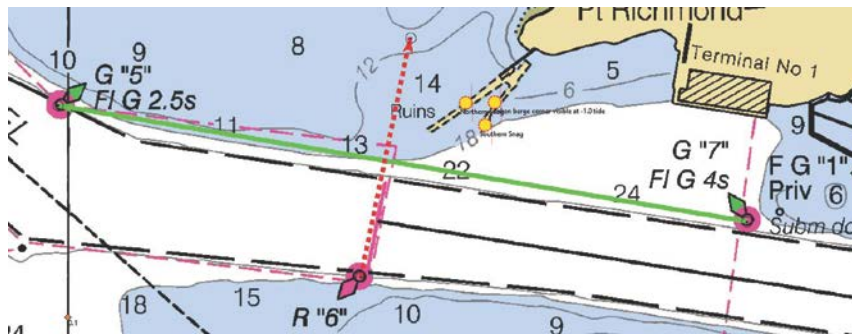
Recommended transit past Ferry Point:

There have been a couple of groundings recently (that I am aware of), so I thought it was time for an update. A minus tide yesterday made it possible to get some good photos of the sunken barge at Ferry Point in Richmond. This barge has been there for a long time, safely hidden by the guide piles from the old ferry landing. Since the removal of these guide piles, sailors have had nothing keeping them from cutting the corner and impacting the sunken barge. The recommended transit (as published since January of this year) past this area is below. **Navigate this area as if the ferry guide piles still exist.**

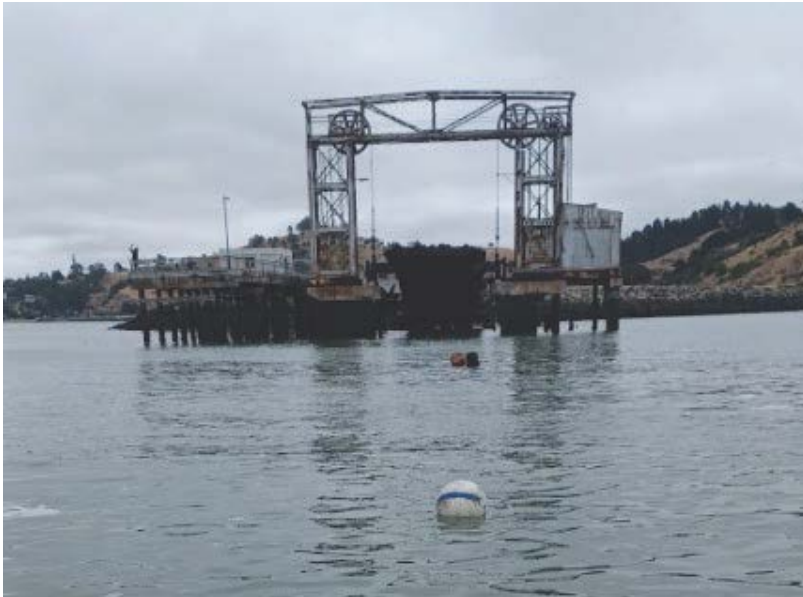
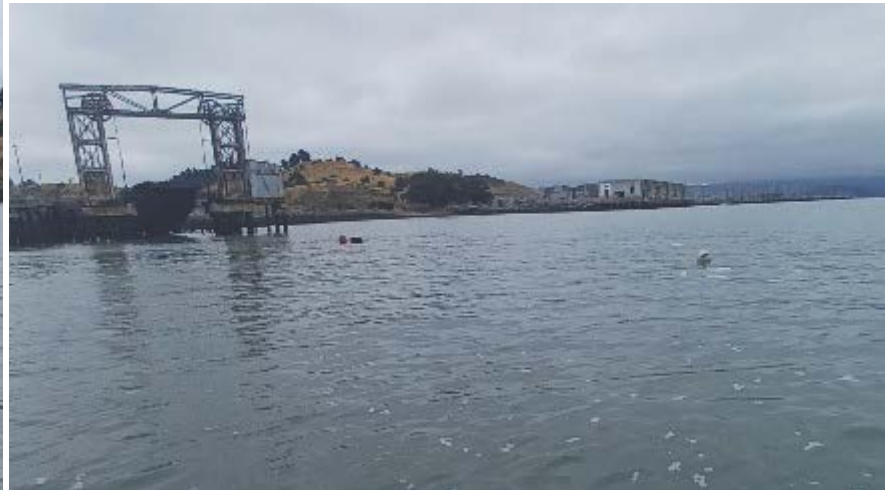
Sunken barge: A second mark has been laid along a SW line formed by the side of the barge. The mark was laid at the point where the deck of the barge drops below the mud line, at a depth of -7.0 ft MLLW. **Do not assume there is clear water between OR beyond these marks.** Again, **navigate this area as if the ferry guide piles still exist.**

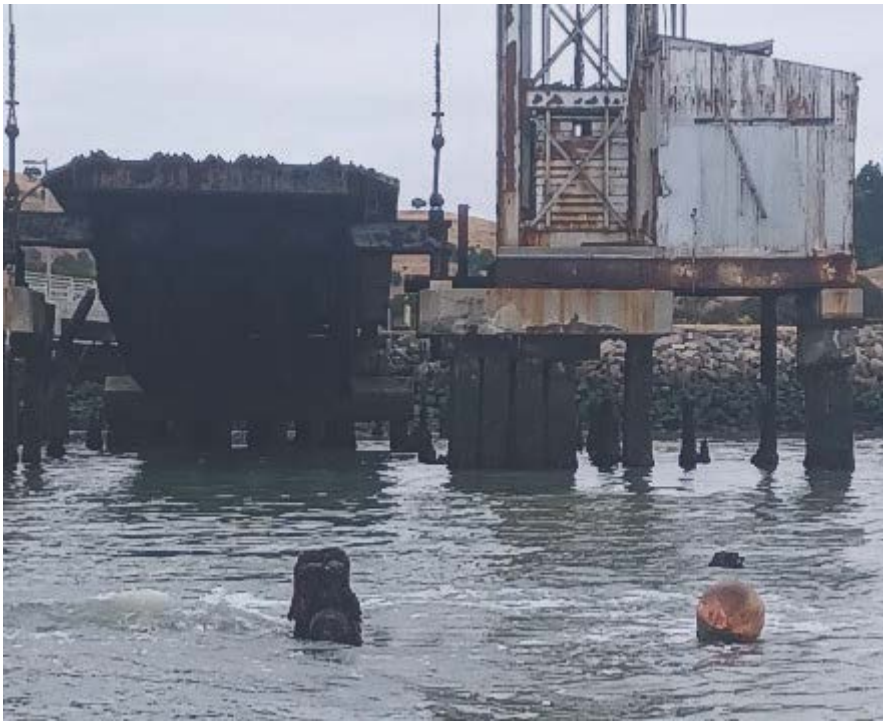
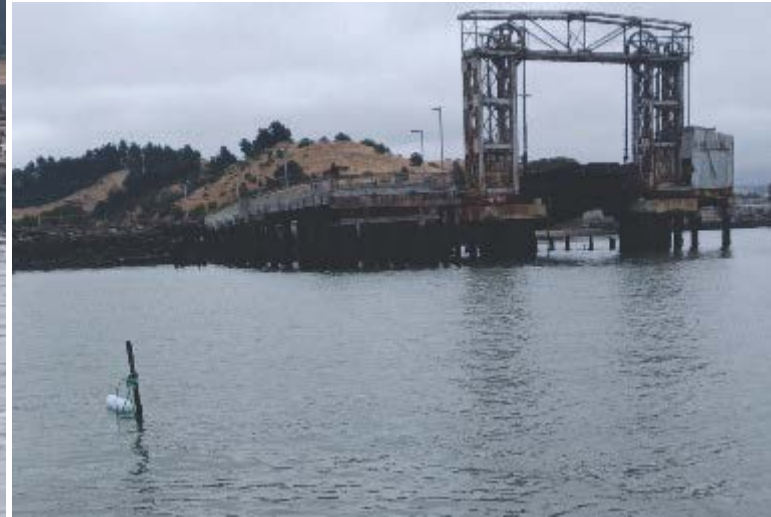
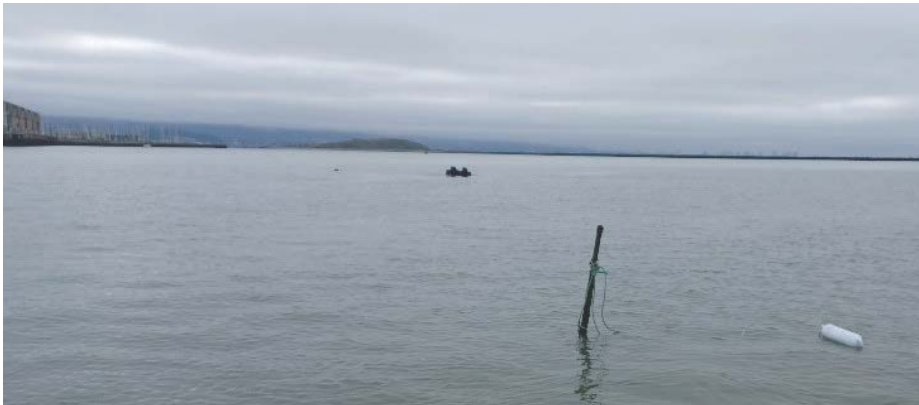
Close-up of the bitt on the NW corner of the barge, and a new obstruction (pipe) found:

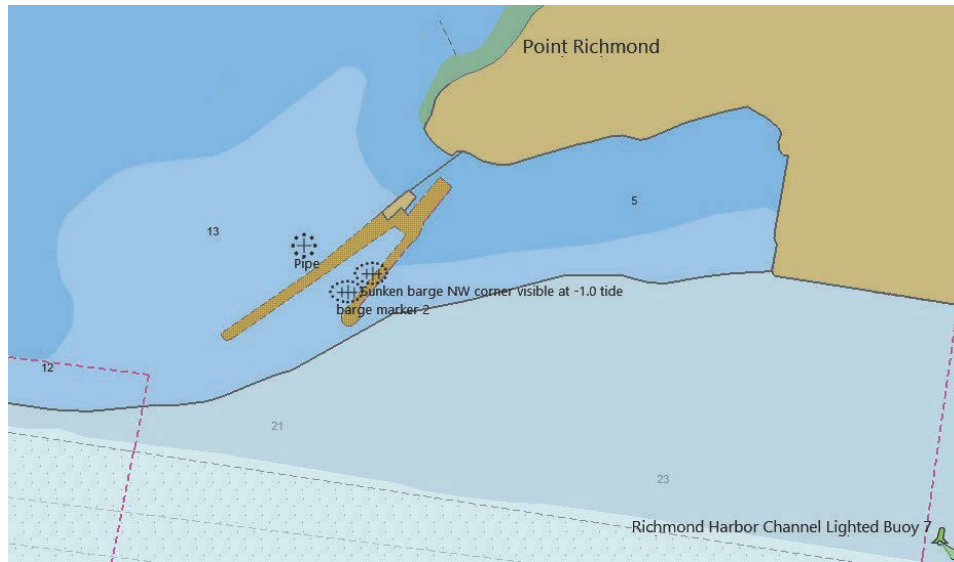
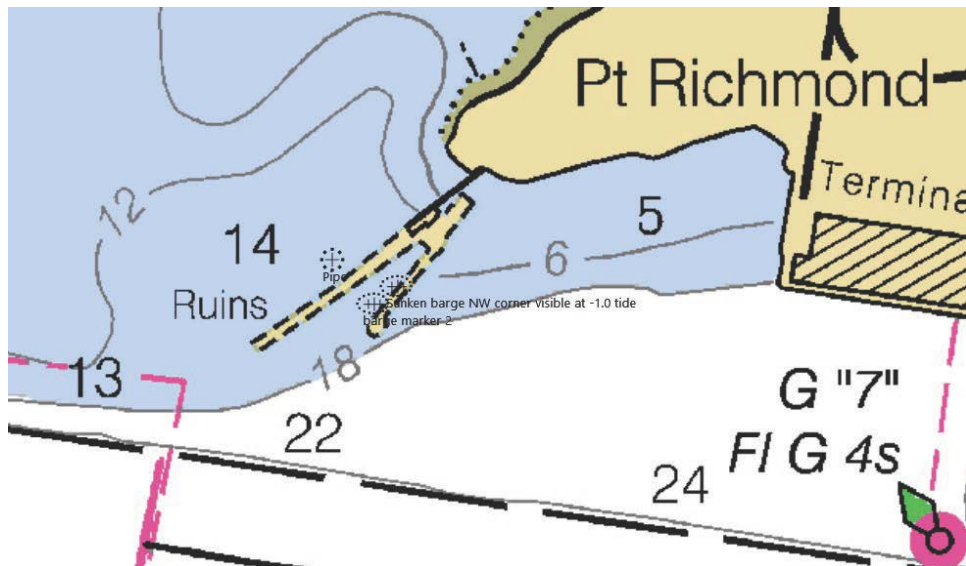
Approximate charted positions of marks: Pipe $37^{\circ} 54.5217' \text{ N}$, $122^{\circ} 23.5163' \text{ W}$; barge marker 2 $37^{\circ} 54.5019' \text{ N}$, $122^{\circ} 23.4940' \text{ W}$; Bitt at NW corner of barge $37^{\circ} 54.5101' \text{ N}$, $122^{\circ} 23.4804' \text{ W}$

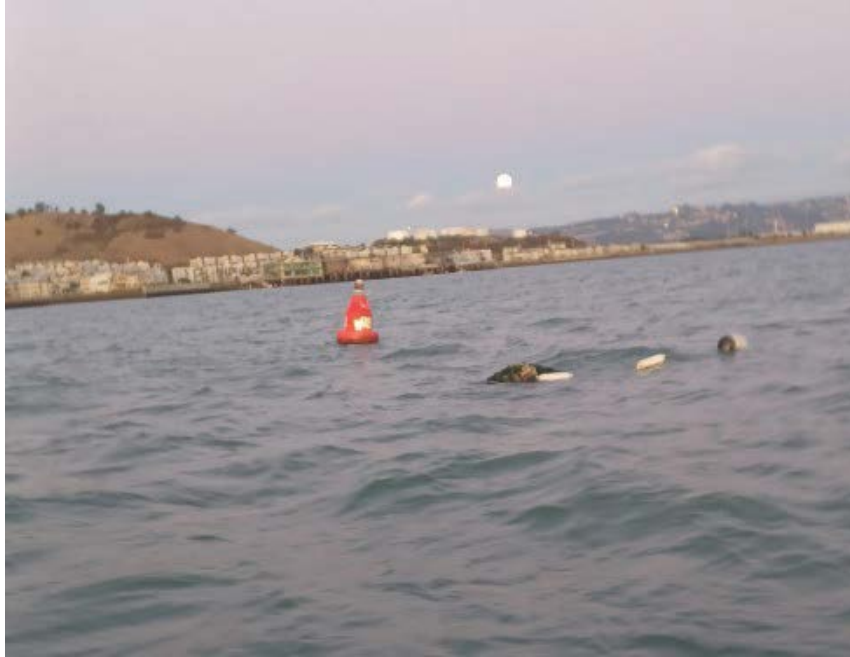
Hazard at "8", just across from the RYC entrance (still exists): the damaged channel marker is lying down at an angle, south of the temporary buoy. The floats are tied to the top structure of the submerged marker. The light cage shows at -0.5ft tide

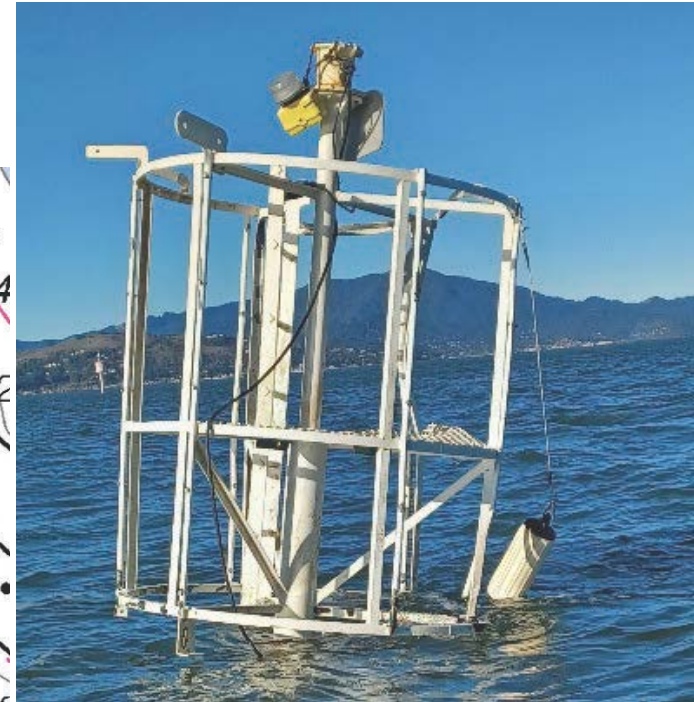
Richmond sewage outfall pipe markers: "2" has no light and can be submerged during high tide and strong currents (still exists): The photo was taken at a 6.8ft tide, 0.8kt current. You can see "1" in the background.

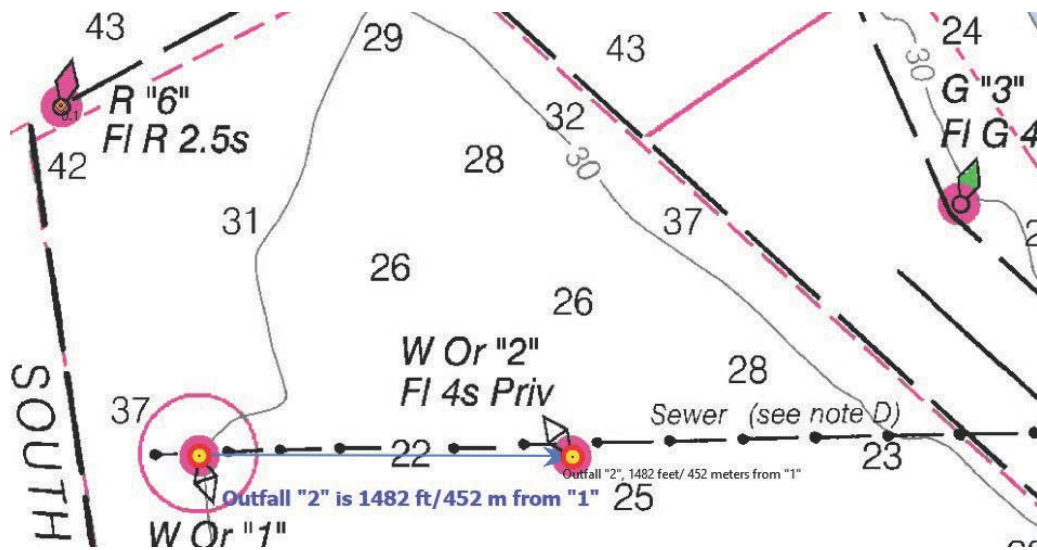
Richmond outfall marker "2" update 30MAY2025

The Richmond outfall marker "2," the one that goes underwater during strong tides, was removed today for service/replacement. It appears that it is being replaced with a similar spar-type floating marker, so expect to see it bent over in a tide as before.

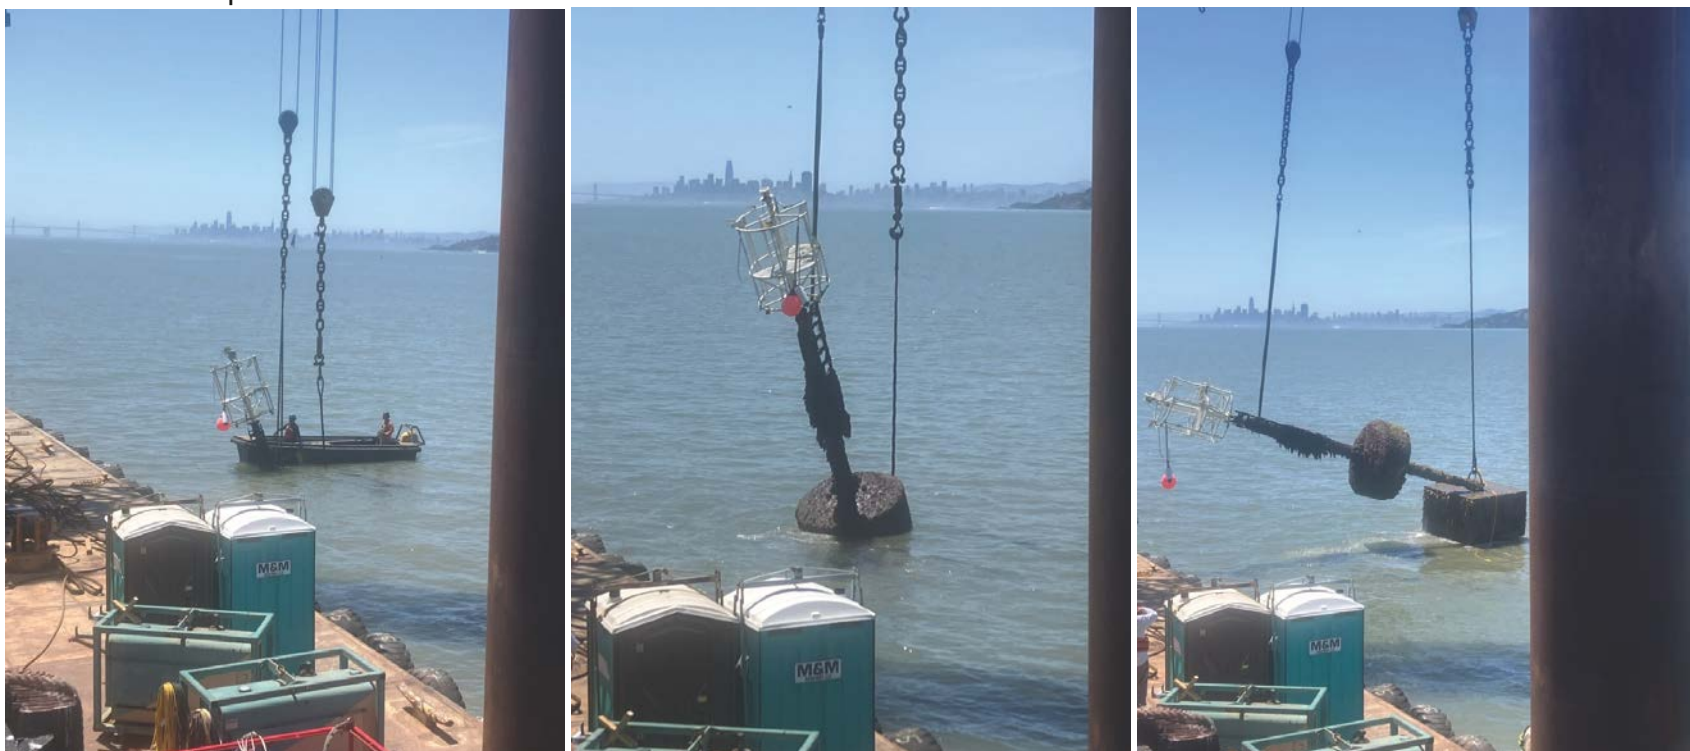
Here are some photos of the removal:

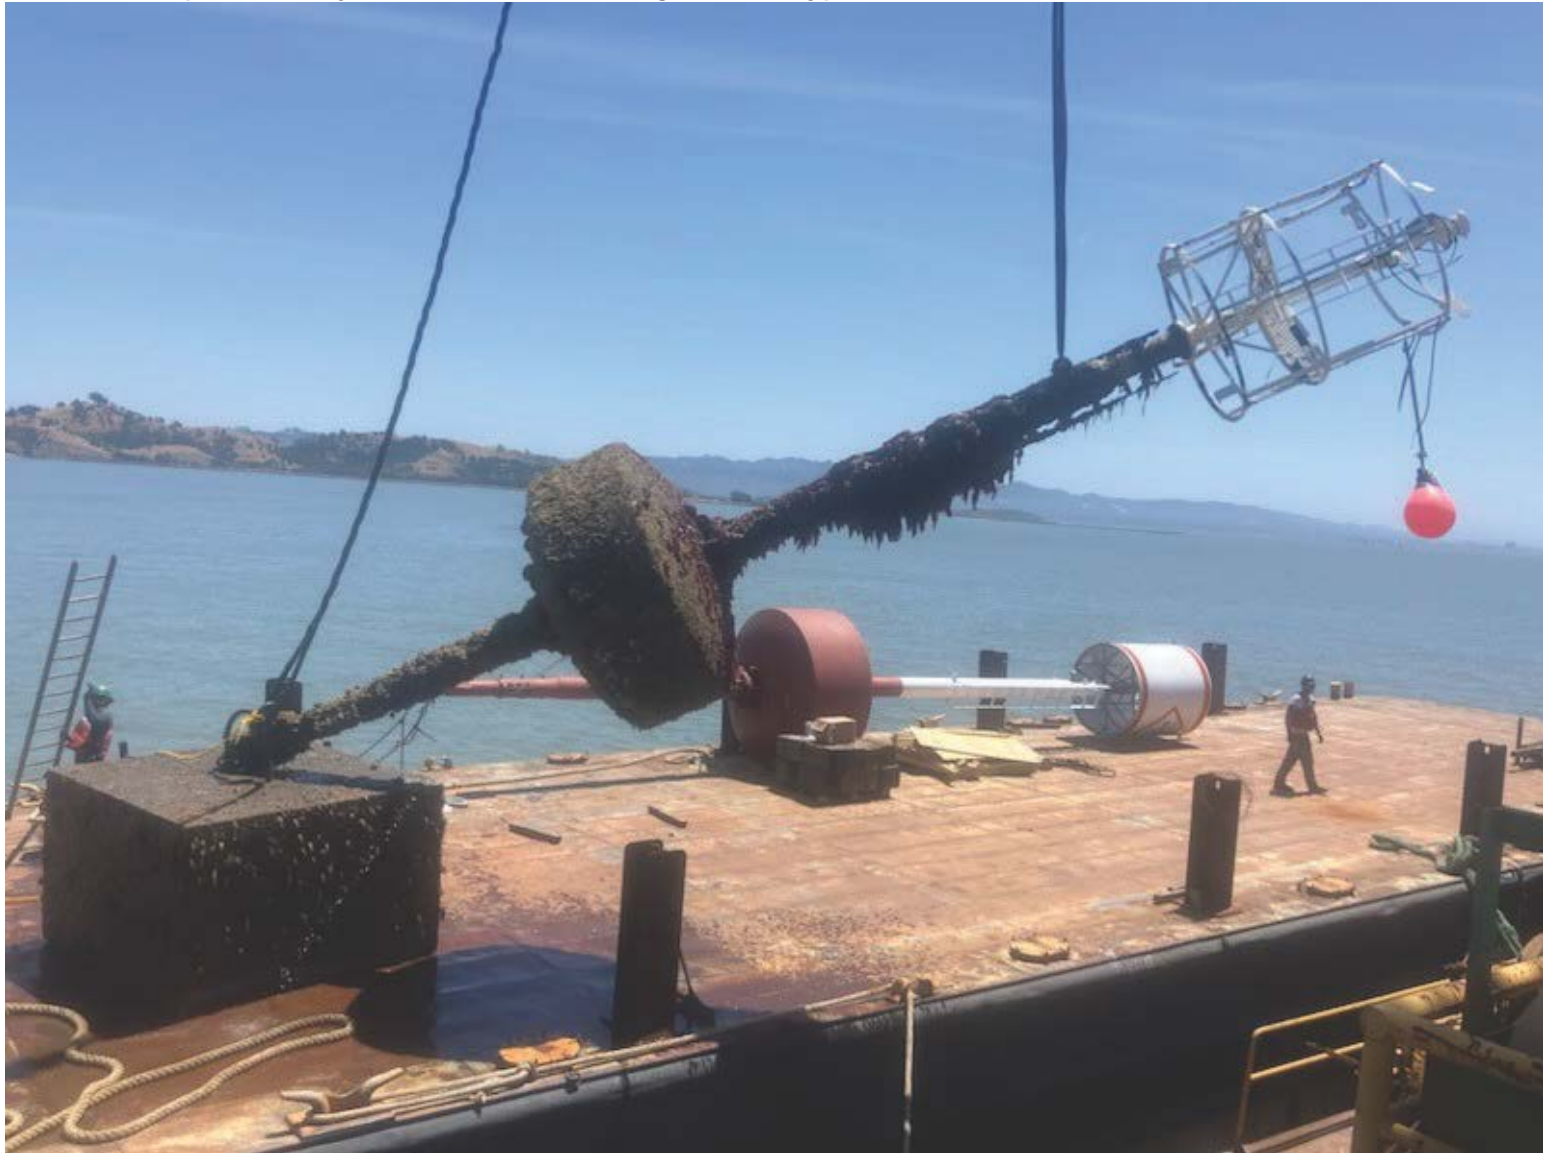
You can see the replacement just behind on the barge. Same type.

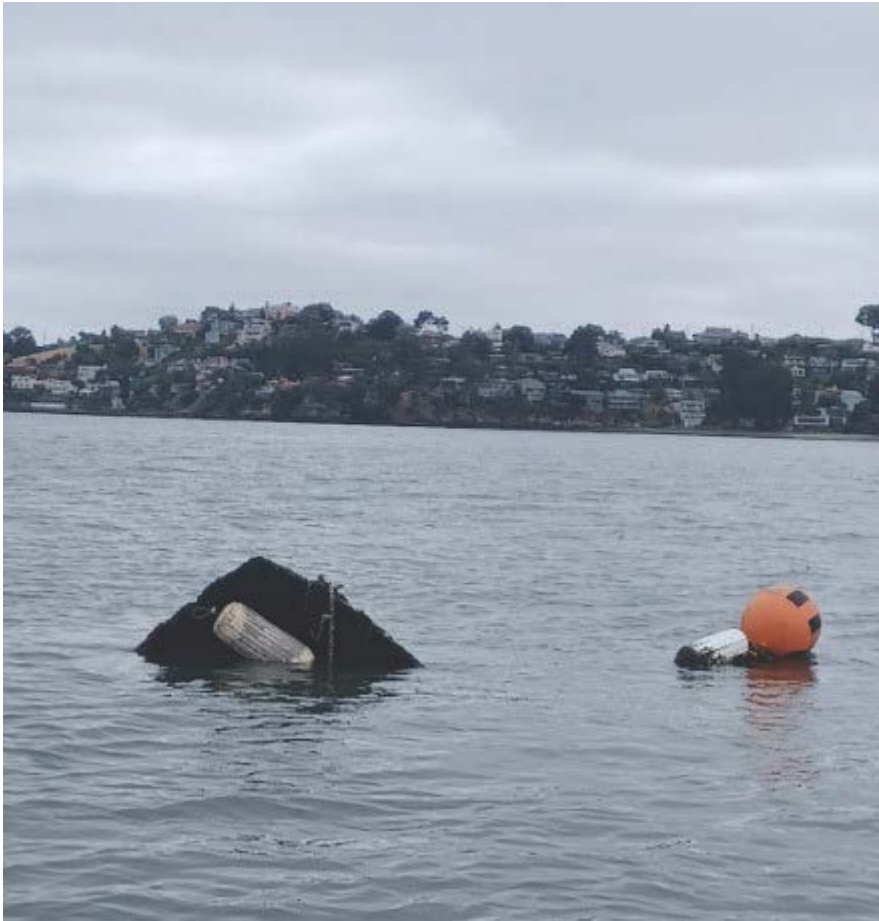
The wreck at Keller Cove (still exists) : It is sitting near vertical, bow up. The tip of the bow shows at a 0ft tide.
